Solving leakage problems on car door assemblies

Description of the investigation

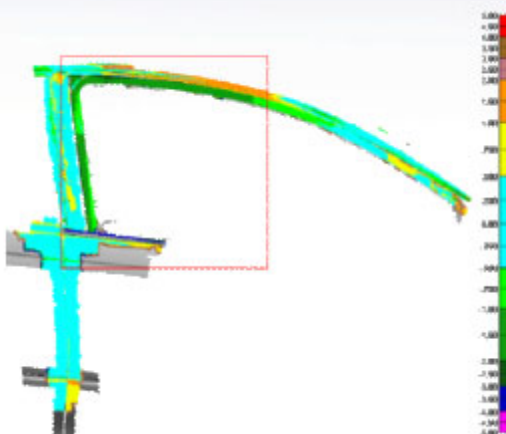
The B-pillar and lower sections of the doors display a light-green (near aqua) color that indicates a deviation below ± 0.5 mm between the two sets of doors. Other regions, like the steel window frame that is welded to the door itself, are illustrated in green, which equals a deviation of ± 1 -2mm. Finally, the orange section, located on the chassis of the car, also indicates a deviation of ± 1 -2mm (Fig. 8-9).

In other words, when the B-pillars of the two cars were aligned to within 0.5mm, the window frames of the leaking car were actually positioned between 0.5mm and 2mm below that of the vehicle that was not susceptible to leakage, a spacing certainly great enough for water to pass through.

Fig. 8: Deviation (orange) on the car chassis

The engineers from Scanning and Inspection actually found that it would be much easier to change the welds responsible for the position of the doorframe than to adjust the chassis in any way. The welding where the windowframe meets the door was adjusted so that the frame didn't sit so low (compared to the door that didn't leak).

The conclusions drawn from the investigation mainly concentrated the concerns of the client to the vehicle's windowframe, or more specifically the way it was being welded to the main door assembly. Suitable adjustments were conducted in relation to the welding treatments to ensure that the window framing was no longer situated too far inside its ideal position, as outlined in the initial CAD design.

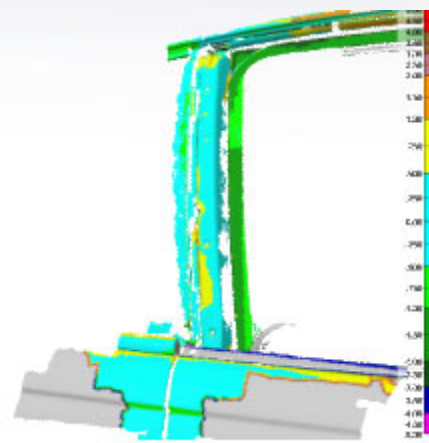
Fig. 9: Deviation (green) on steel window frame
