Solving leakage problems on car door assemblies

Description of the investigation

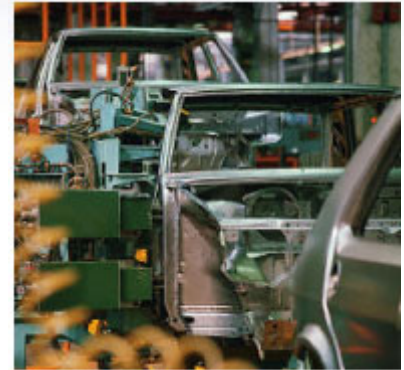
Fig. 1: Car assembly

If one batch of the automotive assemblies were coming out of production and were experiencing no leakage problems, and others being produced at a later stage were leaking, then they must somehow differ in their structure (Fig. 1). How does the problematic door frame assembly differ from its 'good car' counterpart? In order to learn what changes need to be made during production, the client needs to be able to quantify the discrepancy. The relationship and the variations between the 'good' and 'bad' door frame assemblies need to be evaluated. A detailed comparative analysis was acquired, and thanks to the latest in laser scanning technology and the PolyWorks suite, it was achieved within hours.

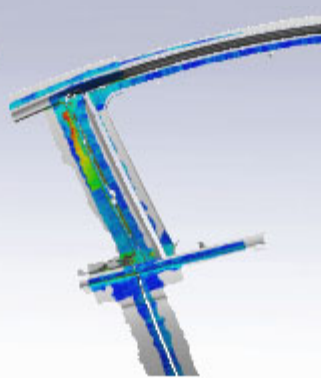
To refine the aligned point cloud obtained from the portable CMM, the PolyWorks IMAAlign module uses these areas of overlaps to realign all scans. First, a deviation analysis was performed on the aligned point cloud. PolyWorks automatically computes the average distances between each overlapping scan and displays a color that represents a deviation value. In a glance, users can identify the scans that are out of tolerance and that can be improved through realignment. (Fig.5)

Fig. 5: Deviation analysis showing scan alignment

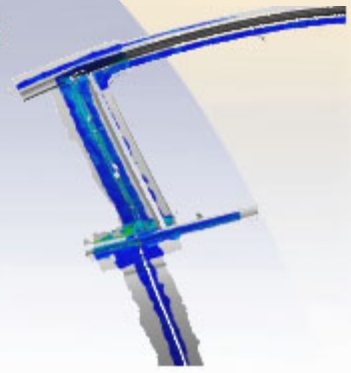
Then, using the PolyWorks "best-fit" alignment technology, a re-alignment was performed. To prevent "sliding" between patches in the same neighborhood, eight control points are automatically set for each scan, which constrain the degrees of freedom. This feature differentiates PolyWorks from other scan alignment solutions, which often encounter sliding problems during scan alignment. After the constrained best-fit alignment is performed, a new deviation analysis is computed and a color map is displayed. Figure 6 shows that all scans were perfectly realigned to each other and are now within the tolerance value.

Fig. 6: Deviation analysis after best-fit alignment
